PHYSICAL EVOLUTION OF A BENTONITE BUFFER DURING 18 YEARS OF HEATING AND HYDRATION

Keywords: radioactive waste disposal; barriers; bentonite; swelling; partial saturation; adsorbed water density

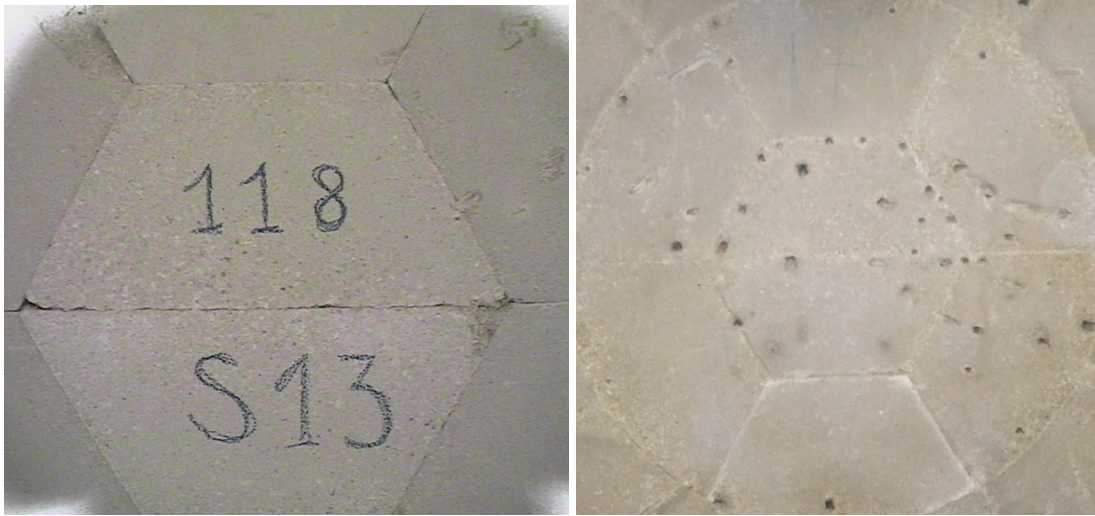
52 Figure 9: Appearance of the core of the barrier in cold zones after 5 years (left, slice 118, section
53 S13) and 18 years (right, slice 17, section S57-S58)

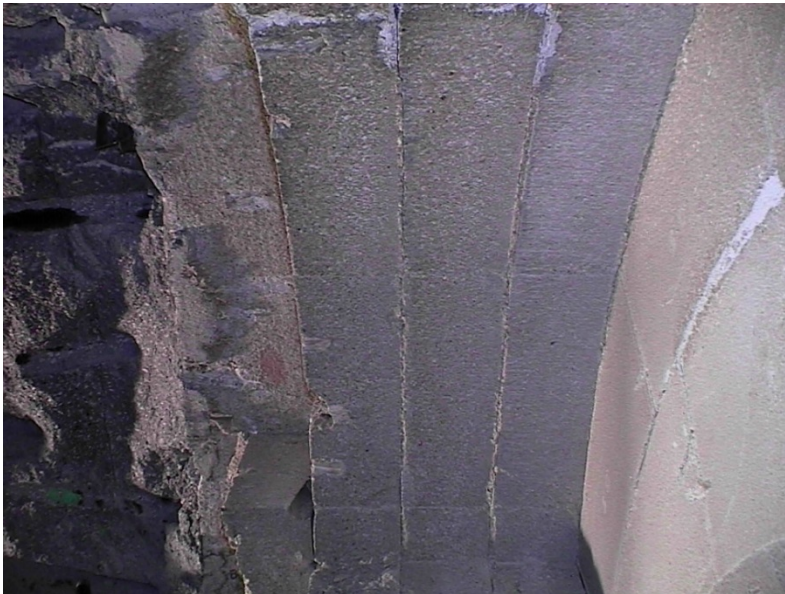
Figure SM-3: View of the external ring of the vertical bentonite slices closest to the gallery entrance during dismantling in 2002. The concrete plug is seen to the left and to the right a non-dismantled bentonite slice

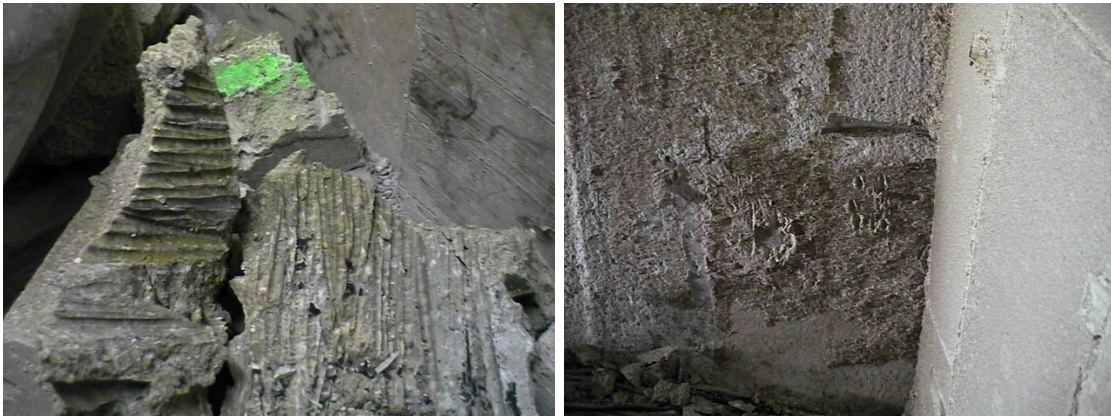
Figure SM-5: Longitudinal grooves on the surface of blocks in contact with granite (left) and bentonite adhered to granite showing striation parallel to the axis of the gallery (right). Photos taken by AITEMIN during dismantling in 2002.
